**Design, construction and monitoring
of a successful snapping turtle
(*Chelydra serpentina*) nesting habitat
site in Niagara College's on-campus
wetland, Niagara-On-The-Lake, Ontario**

**Martin Smith, Environment Department
Niagara College**

**Presented at the Toronto Zoo Turtle Stewardship
and Management Workshop, March 17-19 2008**

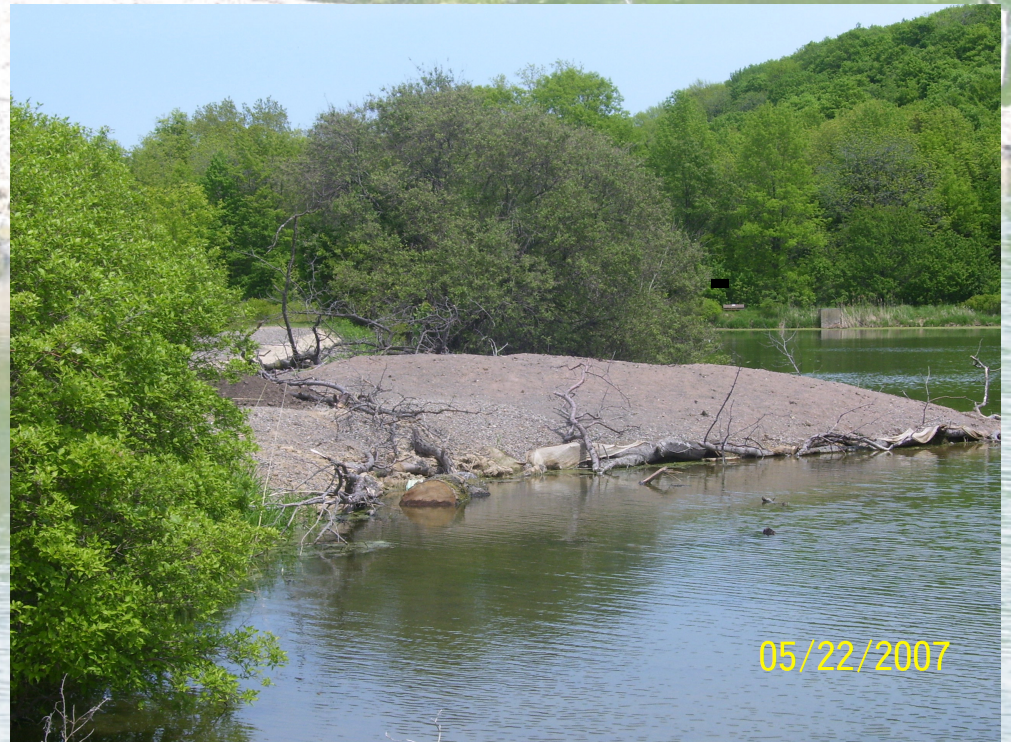
- Design nesting habitat such that it spans the berm separating the two lagoons.
- Orient habitat south to north, providing exposure from full sun to partial shade.
- Recontour berm, reduce slopes and expand available area into lagoons.
- Apply 30 cm deep flat/sloped zones of construction sand or 3/4" crushed gravel.
- Remove vegetation and discourage plant growth.

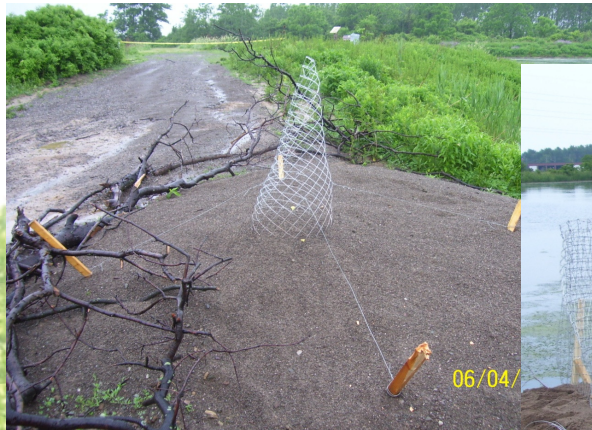
**First design of barrier,
June 4, 2007**

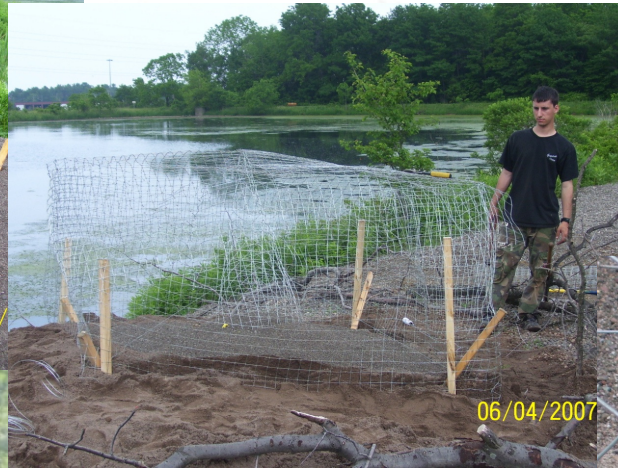
**Final barrier,
June 4, 2007**

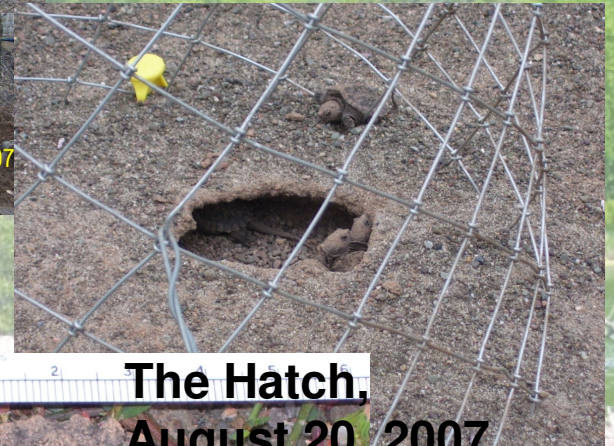
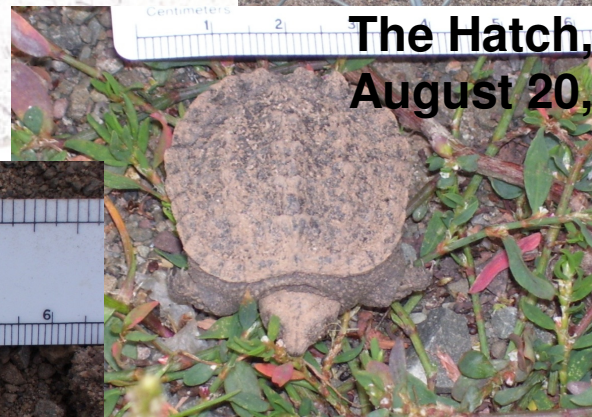
**The Hatch,
August 20, 2007**

- **On June 2 (Friday night!), the snapping turtle female(s) laid at least five clutches of eggs in the lagoon area.**
- **Two clutches laid in the constructed habitat.**
- **One nest in the constructed habitat was immediately destroyed by predators, as were three others built in muskrat holes in the clay berms.**
- **The remaining clutch, located on the central mound of construction sand, was immediately protected by a wire mesh fence and monitored for the next 79 days.**
- **On August 20, 34 hatchings were observed emerging from the nest.**
- **The nest was excavated, revealing that a total of 58 eggs were laid, of which only one did not hatch.**

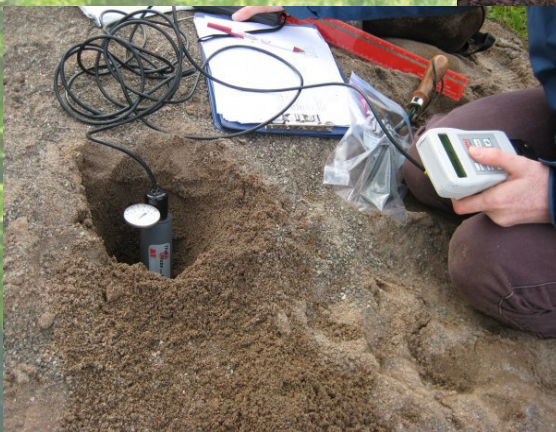
**Substrate sampling
(Toronto Zoo)**

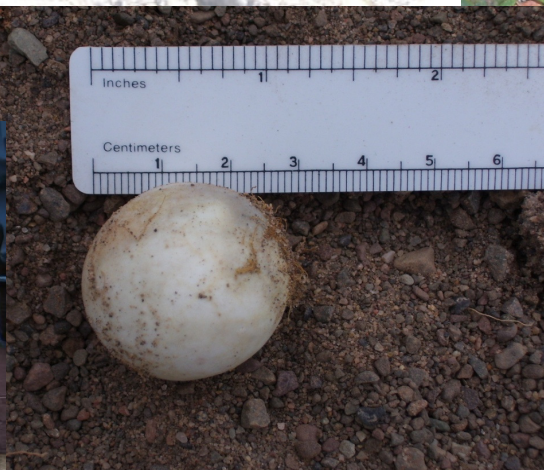
**One of the 58 eggs
did not hatch**
